# Manhole Inspection Summary

Manhole # S45MM\_042MH

Insp Date: **3/25/08 1:07 PM**

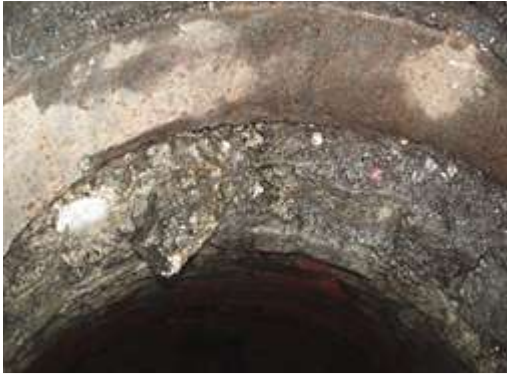
Defect 4

offset

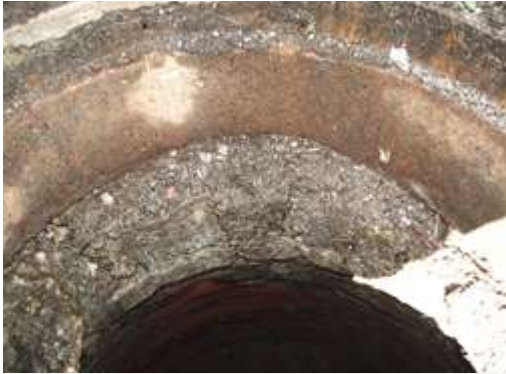
Defect 3

offset

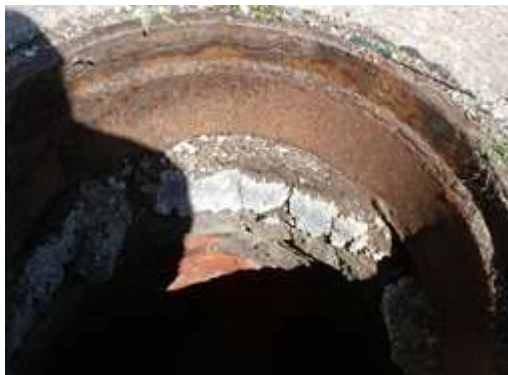
Defect 2

Loose Bricks

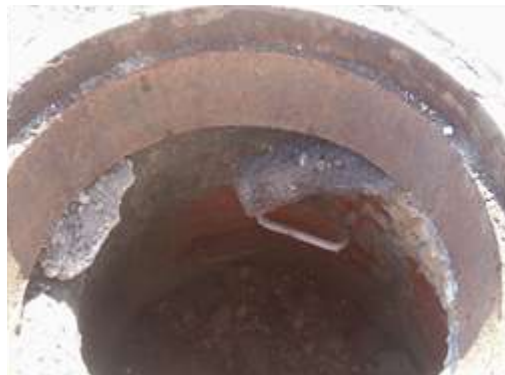
Defect 1

Deteriorated

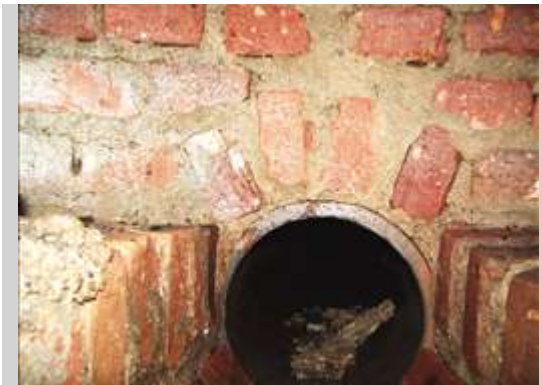
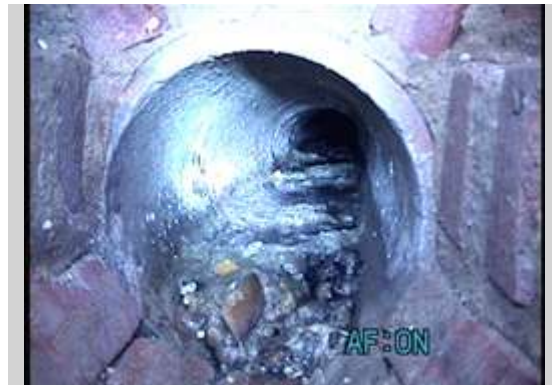
8 in. Circular Gravity Sewer  
Pipe In @ 9 O'Clock

Pipe Height: **8.4** (in.) Rod and Bar (Angled)  
Pipe Material: **Clay** ☐ Pipe Lined  
Invert Depth: **6.80** (ft.) Flow Characteristics: **None**  
Deposits: ☐ None ☒ Mud ☒ ~~Gravy~~ ☒ Debris ☐ Grease  
Silt Depth: **3** (in.) Deposits Extent: **Medium**  
Infiltration: **None** Pipe Seal Cond: **Sound**
